NRL/MR/7130--03-8685

Preliminary Observations Regarding LDV Scans of Panels Excited by Broadband Actuators at the U.S. Capitol

*Physical Acoustics Branch
Acoustics Division*

November 7, 2003

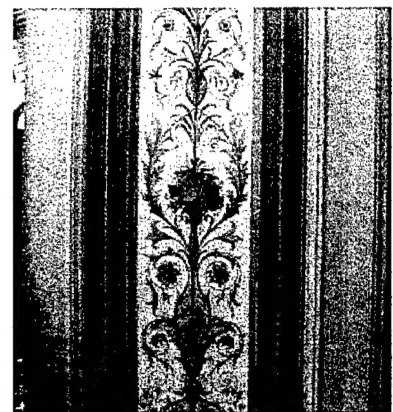
Figure 1 – “Pineapple” Panel

characterized as simple in the sense that tapping tests indicate defect areas that involve less than 10% of the total panel area. Panel 2, on the other hand, is more complex in that at least 50% of the panel area appears to have some defects. The scan density was every three cm for panel 1 and every one cm for panel 2.

We first discuss the measurements taken on Panel 1 (see Fig. 1). Simple sequential observations (see Figs. 2a - 2g and Figs. 3a - 3f) of the velocity scans (phase and amplitude) at each three Hertz increment indicate that we have obtained meaningful data on panel 1 over the band from about 80Hz to 1KHz. From 80Hz to about 400 Hz we can observe what appears to be simple wave propagation from the lower left corner where the actuator is located up toward the upper right hand corner. This seems especially clear from the phase plots. The wave speed is very crudely estimated to be about 700 m/sec over this lower band, suggesting shear wave propagation in the plaster. Beginning just below 400 Hz one can see even higher motions over a smaller patch size (about 18cm by 26 cm) near the right edge just above the scanned panel center. It appears strongest at about 460 Hz and seems to fade in and out with something like a 25-40 Hz period. At about 670 Hz, the motion over this patch breaks into a two-lobe mode pattern. Both the extent and location of this mobile patch coincides with a defect area discovered earlier in the tap test data. We should point out, however, that the same tap test data seems to indicate another defect area on the left, a location where we do not see any obvious localized high levels of motion in the LDV maps in this frequency band.

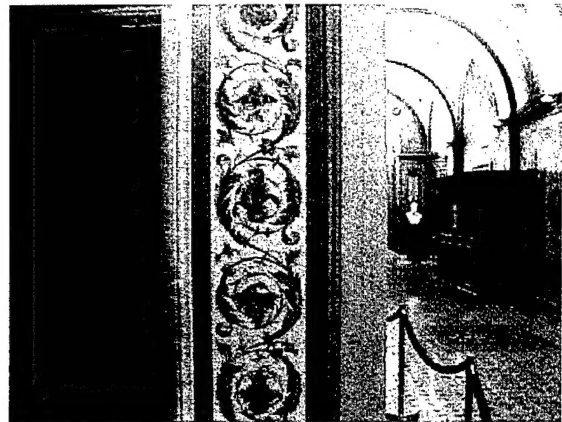
Figure 5 - "Eagle" Panel

Panel 2 (Fig. 5) is on what is known as a pilaster, a segment of the wall that protrudes rectangularly from the wall. Observation of the velocity phase plots (see Figs. 6a - 6l) indicates that we have obtained meaningful data on this panel 2 from about 500Hz to 6KHz. Generally, what appeared as simple wave motion (shear) in panel 1 can be seen again in the panel 2 data up to about 1KHz. However, the higher frequency panel 2 data which is available beyond 1 KHz begins to look more modal in character. However, the spatial mode structure still seems to be related to shear wavenumbers. As in panel 1, at the lower frequencies (below about 1KHz) a local patch with high mobility is readily seen against the long wavelength wave motion. However, as frequency is increased, it becomes more difficult to notice such regions because of the modal-like structure of the base panel motion. However, at some frequencies it is still possible to do so when the local patch motion reaches high enough velocity levels. This is the case, for example, at around 800Hz and 980Hz where a high mobility patch can be observed just in from the left panel edge at the vertical midline; between about 860Hz and 930Hz where both this patch and another below and just to the left of it can be seen; at about 1070 Hz, 1200 Hz, and 1290 Hz where in addition a second patch near the top can be seen; at about 1400Hz, 1500Hz, 1800Hz where this upper patch becomes isolated; and at five or so frequencies above 5 kHz where only a new, highly localized patch (about 2cm in extent) can be seen in the lower quadrant just right of the panel center. It may be fortuitous, but we can make a simple comparison between this result and that for the mobile patch seen in panel 1. In particular, the panel 1 patch is about 20cm in extent and first appears (resonates) at 420Hz whereas the panel 2 high frequency patch first appears at about 5.2 KHz and is about 2cm in extent. The ratio of the two frequencies is 12 which is close to the inverse ratio of their spatial sizes (10). This relationship would be expected for the resonance of two patches having identical thicknesses but different lateral extent.

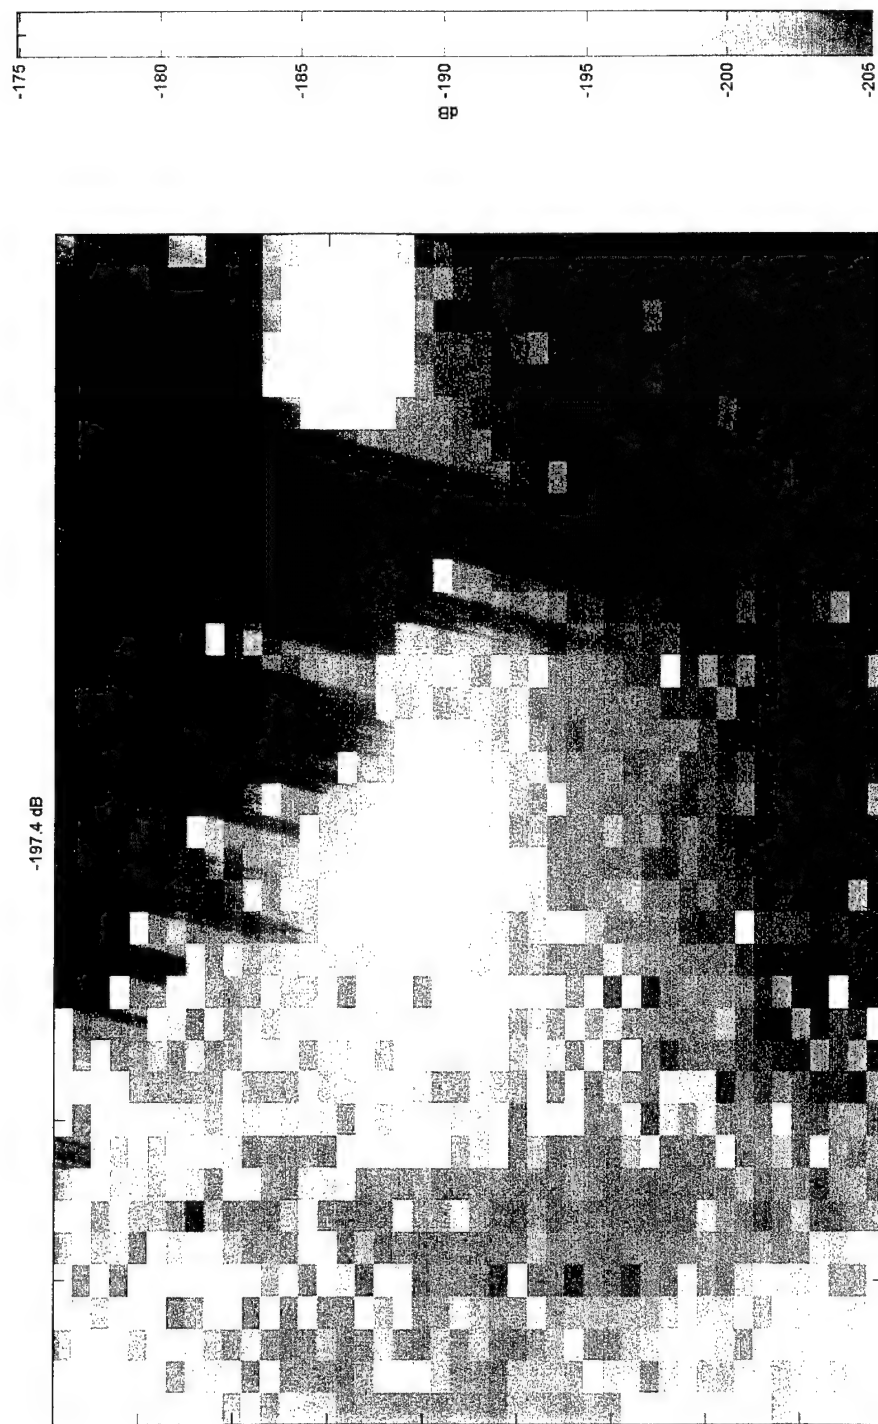
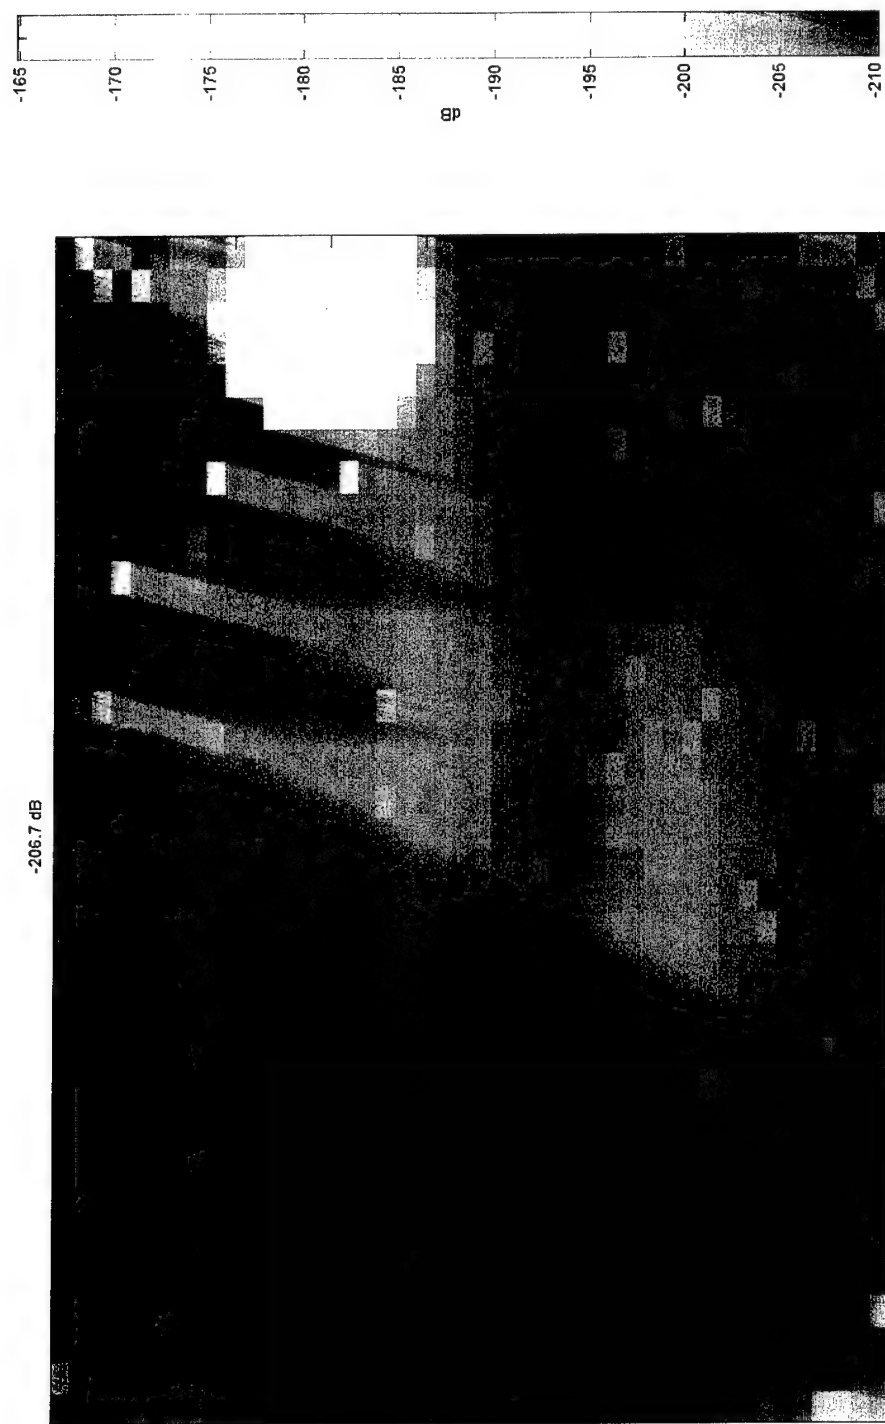
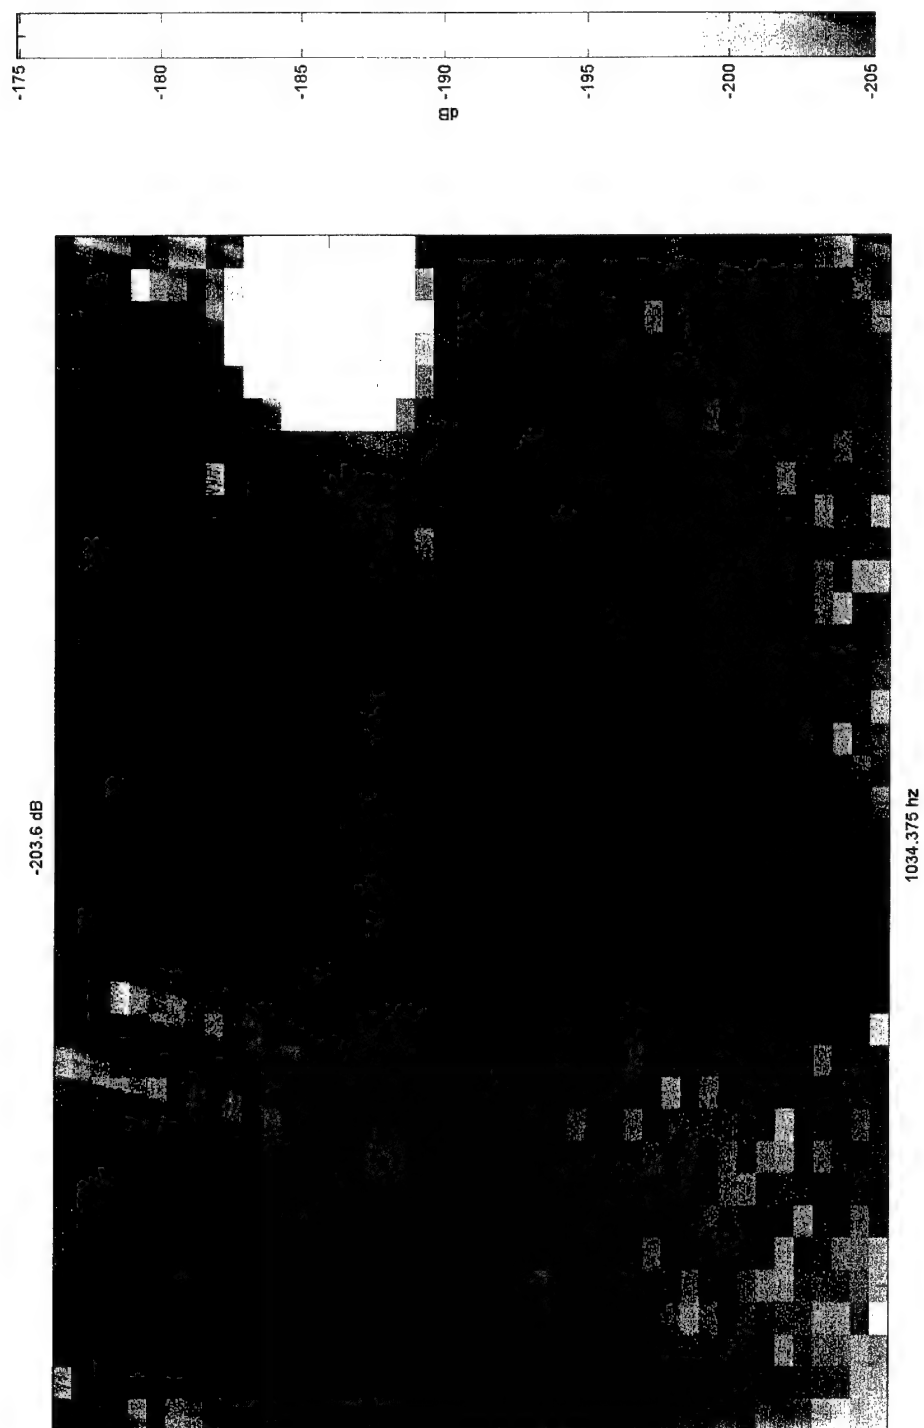
An attempt was made to combine the individual narrow-band scans into a broadband map. We did this by forming the sum over the frequency bands of the properly normalized quantity $|VV^*|$ at each spatial point. The resulting maps are shown in Figs. 4a - 4c for the full band and two partial bands, respectively. In addition to the dominant mobile patch in the upper right previously discussed, there appears to be additional larger areas with levels lower by some 30dB. As can be seen in Figs. 4b and 4c, these seem to be dependent on frequency. At this point, we are not certain whether these broader features are actually related to increased mobility of the structure or a signal to noise related artifact.

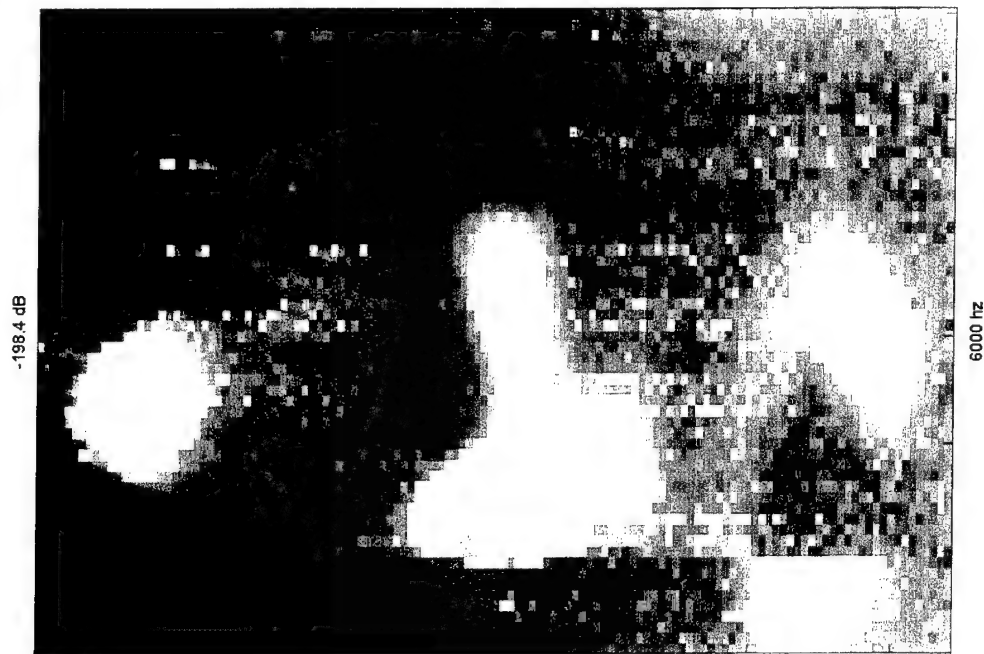
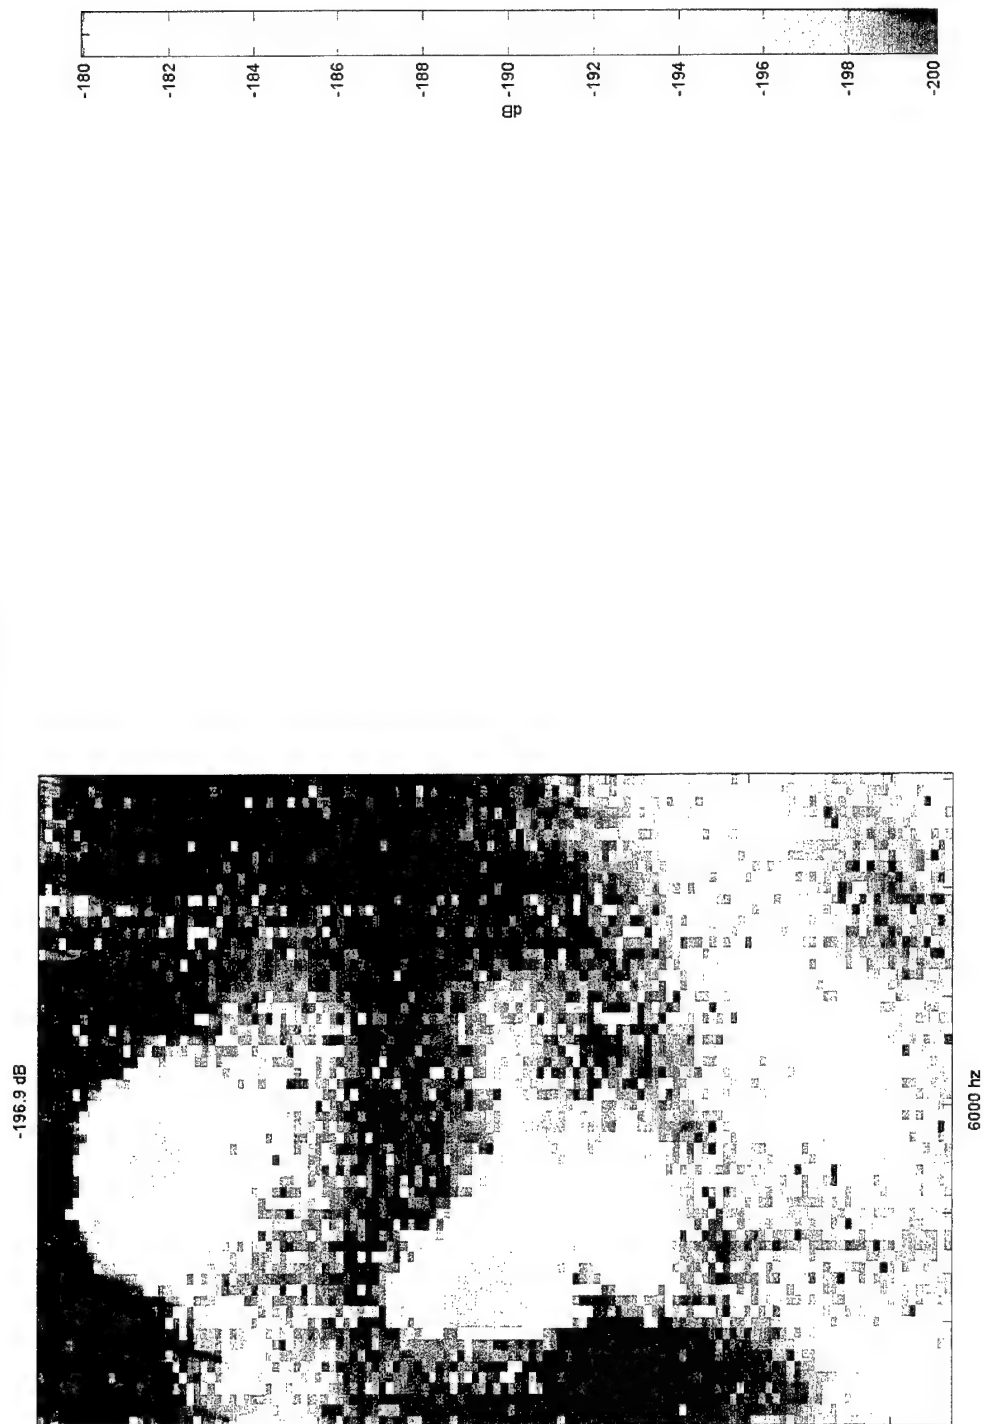
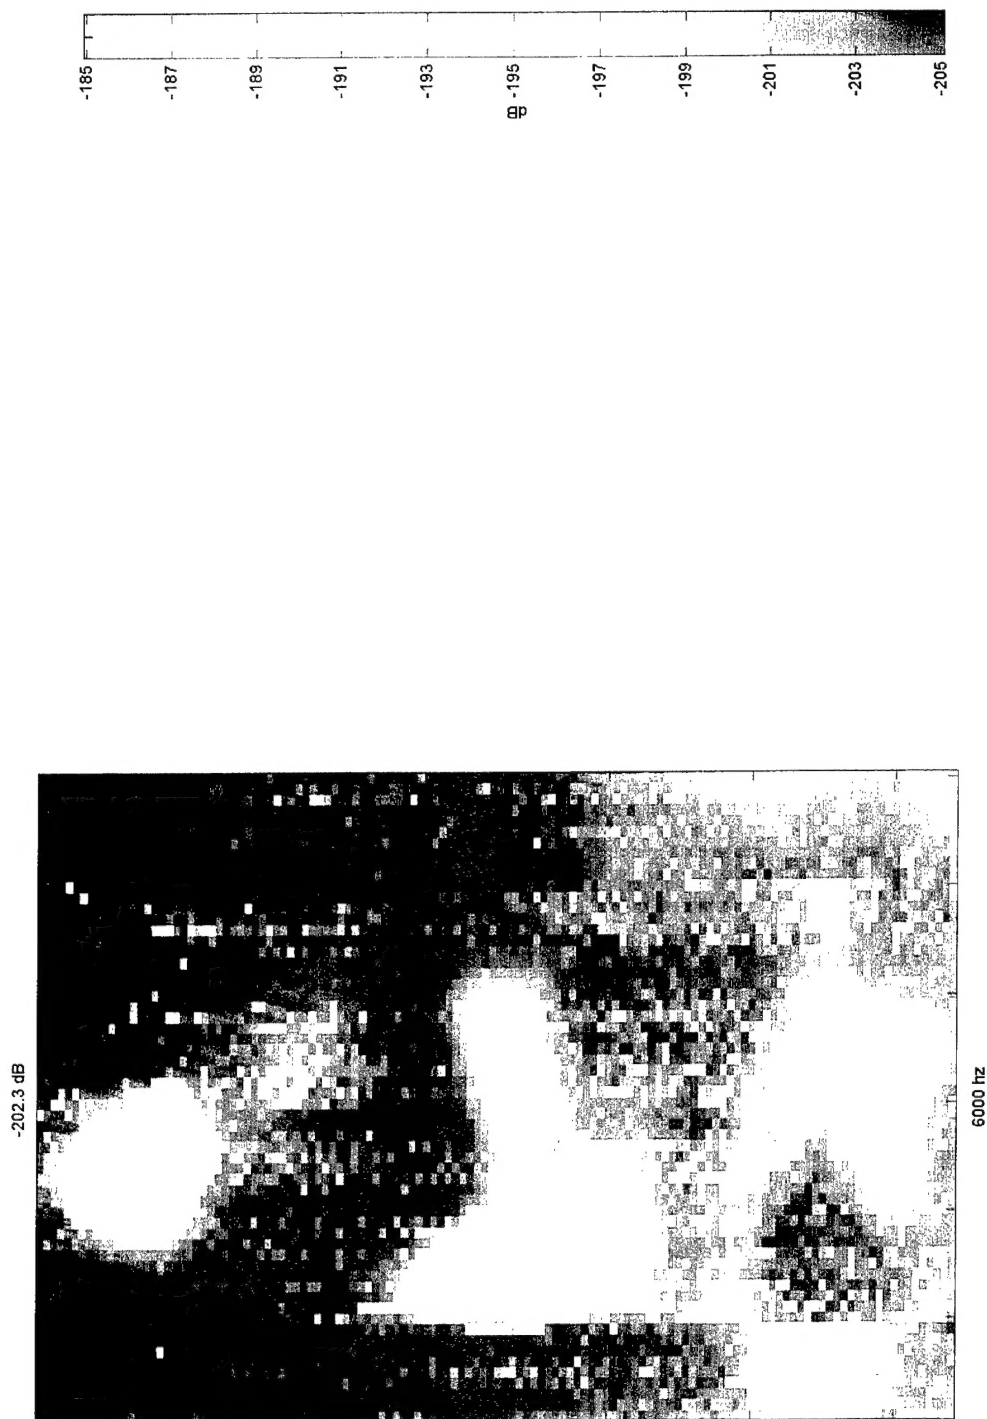
In Figs. 7a - 7c is shown the normalized $|VV^*|$ quantity for three different bands at frequencies below 2KHz. The above mentioned features for these frequencies now appear even more pronounced, presumably due to the frequency

averaging (and thus smearing) of the background modal structure of the panel. There also now appear three other mobile patches, one at the panel center, one below that point near the bottom, and one just below and to the right of the second patch from the left. Finally in Fig. 8 is shown the normalized $|VV^*|$ quantity for the entire band, 770Hz to 5KHz. Here all of the above features can be seen. This figure seems to indicate a total defect area of about 30-40%, a number consistent with the 50% level estimated with the tap tests. In addition, the broadband motion now clearly reveals two vertical discontinuities, the sharpness of which suggests they are connected to the structural design of the panel.
